Noel Jellyman Building Consultants Limited

DEFECT

Engaged to inspect a building and carry out a “Building Envelope Condition” report, I came across a defect that I had not seen before.

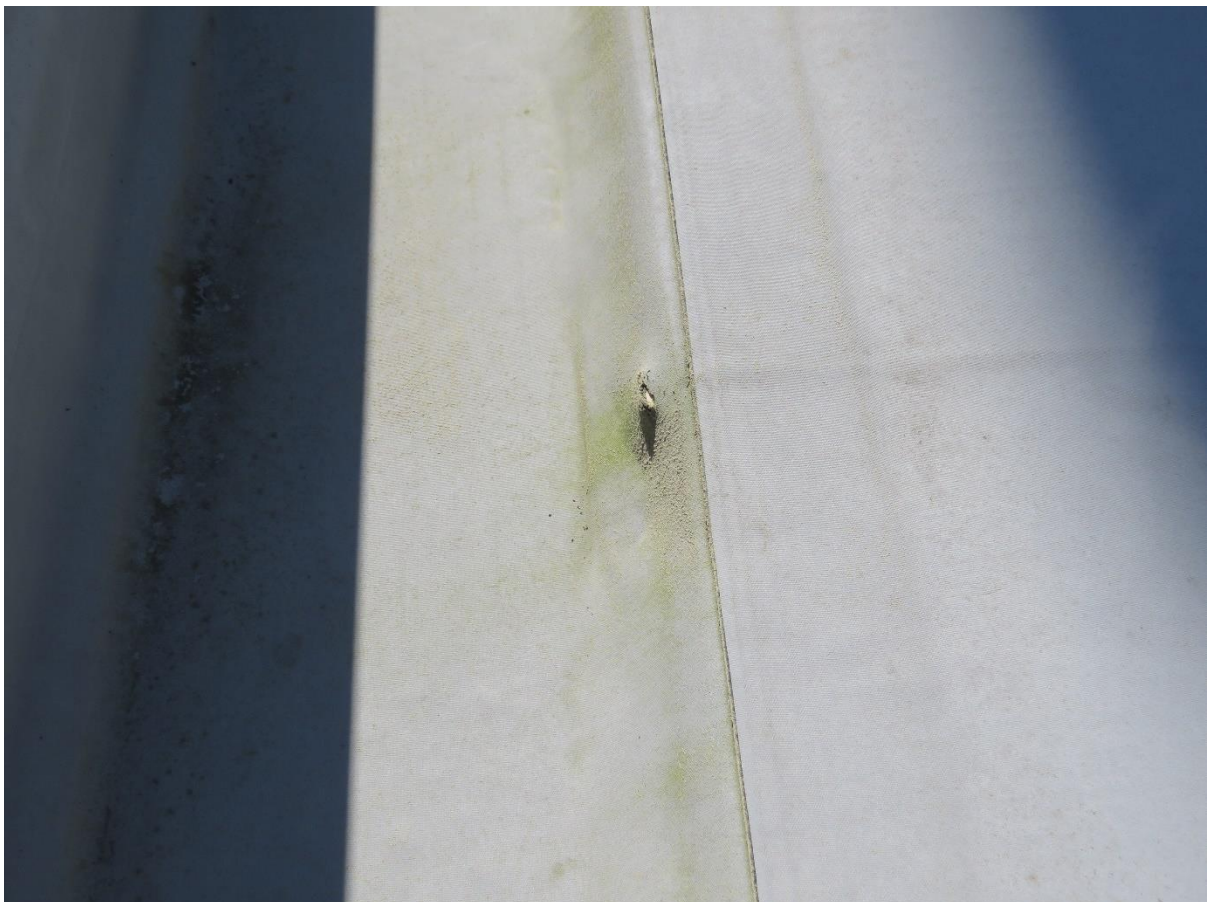
The roof was a 100Mtr² Butynol Membrane over Plywood substrate – Non trafficable area. The plywood had been joined using a groove in each sheet with a uPVC biscuit. Thermal movement in the uPVC had pushed the uPVC jointer through the membrane at most sheet joins and on both sides of the roof.

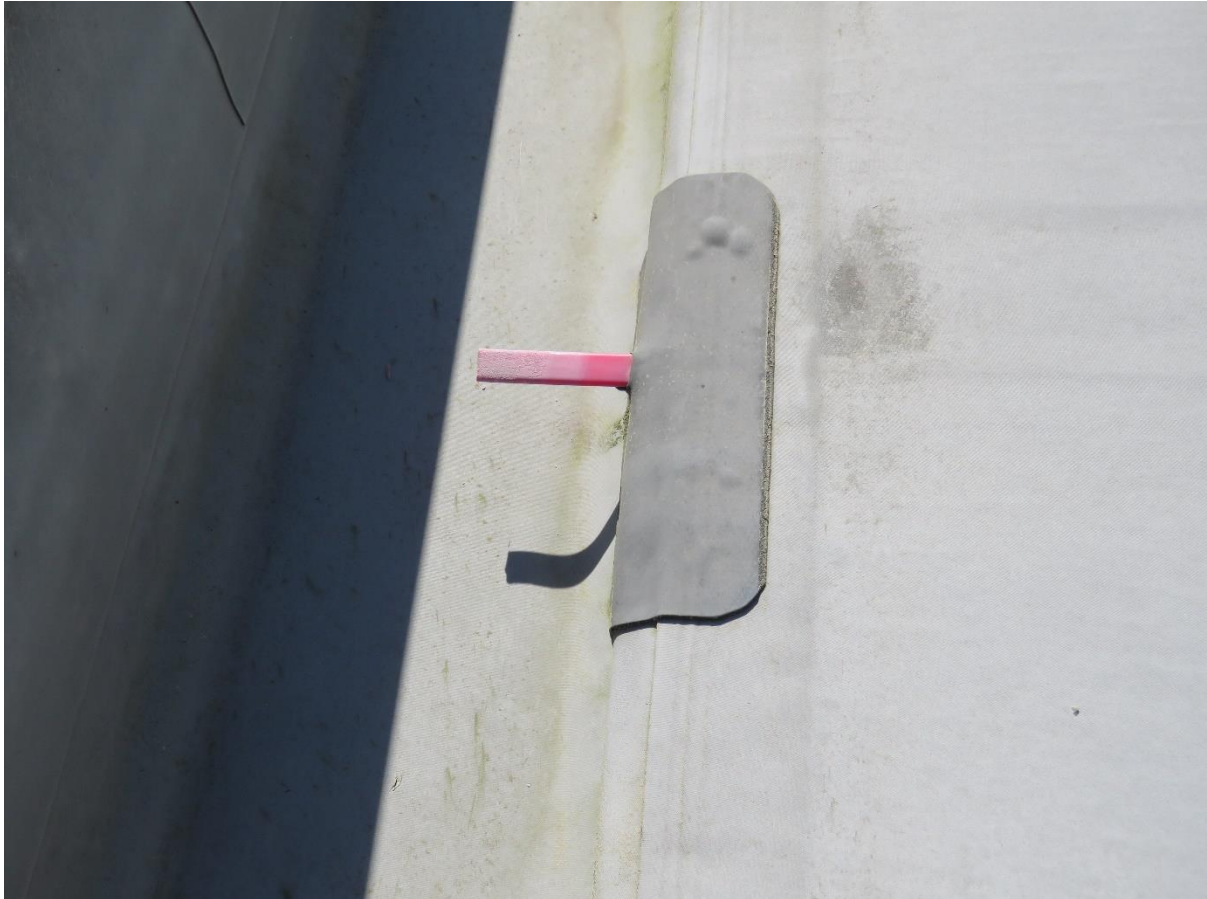
When uPVC expands and shrinks on a cyclical daily basis, it moves in the same direction which is the direction with least resistance. It moves like a caterpillar. The daily movement is so small it is undetectable. Over a period of 10 years or more, however, it becomes pronounced and obvious, as seen below.

In this case scenario, at this joint, the membrane had been repaired once, but the uPVC had pushed through again.

If a single screw had been placed to lock the uPVC prior to the repair, would that have prevented the defect recurring?

Would the patch repair have been sufficient had single screw been installed through the joint to lock the uPVC biscuit in place?
